Risky Business

Using a Risk-Based Inspection Program to Anticipate CUI Issues

From *JPCL*, June 2021

By Peter Bock, Performance Polymers Americas LLC

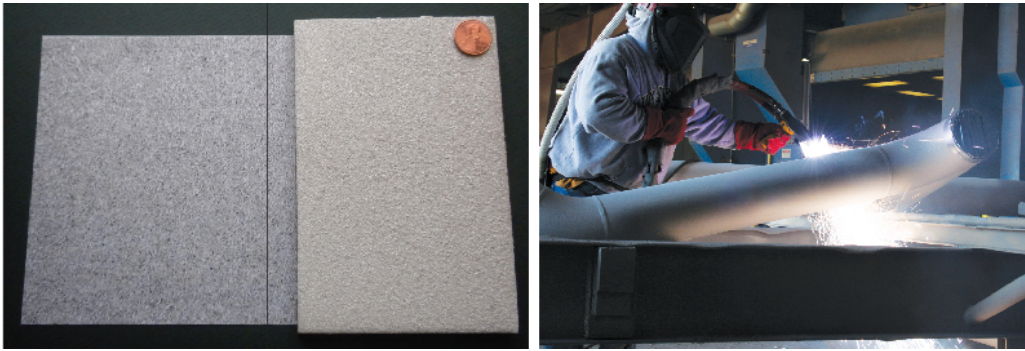
Fig. 1: Thermal spray aluminum is a single-coat instant dry CUI coating with very wide temperature tolerance and good service life. TSA requires specialized inspection after application; properly applied TSA is nearly identical in appearance to fresh white-metal blasted steel. The sample panel with the penny is the TSA. Photos: Courtesy of the Author

Another recent CUI preventive system is thermal spray aluminum, otherwise known as metalizing. Thermal spray application is closer to metal brazing or arc welding than it is to spray painting. Thin aluminum wire is melted in a torch flame or electric arc, is broken into very small droplets, and is then blown onto a properly prepared steel surface. The basic process has been around for a century, but despite its appearance, the resultant film is not equal to aluminum plating for several reasons. Although there is more aluminum than in plating, a large part of it is in the form of oxides, which are slower sacrificing than aluminum plating, making the thermal spray aluminum film a suitable long-life CUI coating even if chemical-laden water penetrates the insulation system.

Thermal spray aluminum film can be applied fairly thickly—typical single-coat thicknesses for CUI are 10–15 mils. The applied coating dries hard, cools very quickly and can be handled with minimal damage almost immediately after application. The comparable work time, against a two- or three-coat liquid-applied system, in which each coat requires an overnight or longer dry time, justifies the much higher application cost. The service life of a properly applied single coat thermal spray aluminum system in CUI service is equal to or longer than the life of a two-coat or three-coat liquid applied system, but has not proven to be two or three times the life of a liquid applied system, as was initially claimed in the early 2000s.

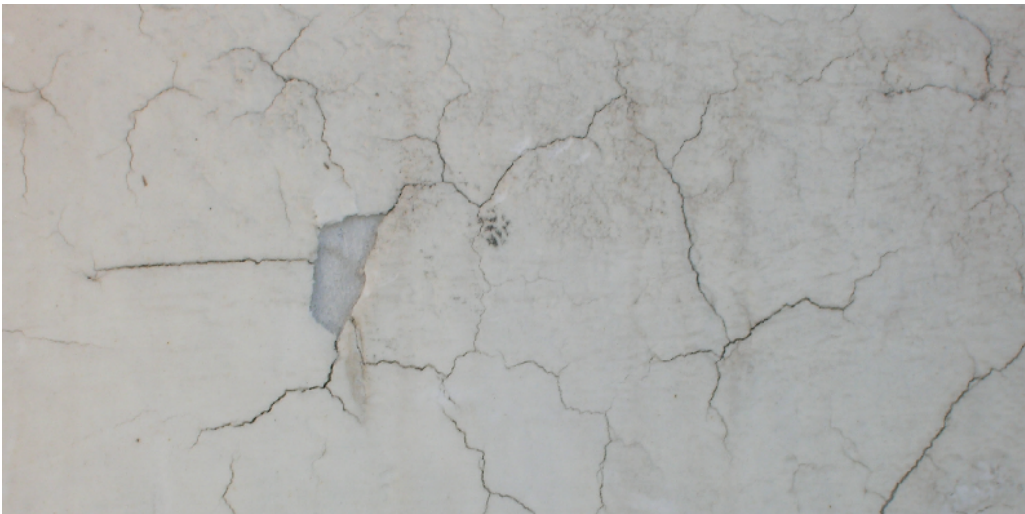
Fig. 2: This acrylic-spray-on insulation failed after two years from excessive film thickness or insufficient dry time between coats during application. The vessel may also have operated at temperatures beyond the acrylic resin's tolerance.

Waterborne acrylic spray-on insulation and epoxy foam are syntactic insulations, where the resin is filled with ceramic or glass microspheres, to produce a syntactic foam. Acrylic is limited by the low per-coat dry film thickness and slow drying time. Ten- and twelve-coat systems and two weeks of drying time are often required for thick systems; a more common use is two or three coats to provide personnel protection on accessible equipment, piping and brackets or to prevent thickening of crude oil stored in tanks where cold weather is a rare event.

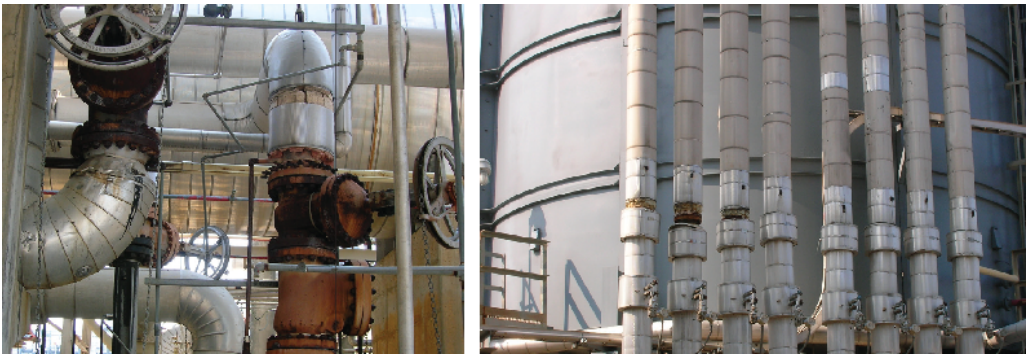
Fig. 3: Poor or unfinished installation, mechanical damage and signs of abuse during access are typical of aged insulation and jacketing in refineries and chemical plants. Evidence indicating a lack of CUI inspection and lack of maintenance on these easy-access feeder runs is clearly visible.

Along with the damage from normal environmental exposure and a refinery's much worse micro-climate, insulation jacketing also suffers from the damages caused by careless or unthinking humans, or by the hurried need to fix one thing without considering potential damage to others. Whether an insulated pipe run or vessel is used as an impromptu ladder, stairway, crosswalk or tool testing area (think hammer drops or large adjustable wrenches) or for a scaffolding extension when the original repair scaffold is just a bit short, the thin sheet metal jacketing and the brittle crushable insulation underneath suffer and do not recover.

Sheet metal jacketing is made up of hundreds, sometimes thousands of precut, preformed pieces, which fit together well when first installed. All those joints may actually seal against water entry when first installed; but they leak like a sieve after having been walked over, beaten on or otherwise abused and cannot be easily repaired once they are deformed.

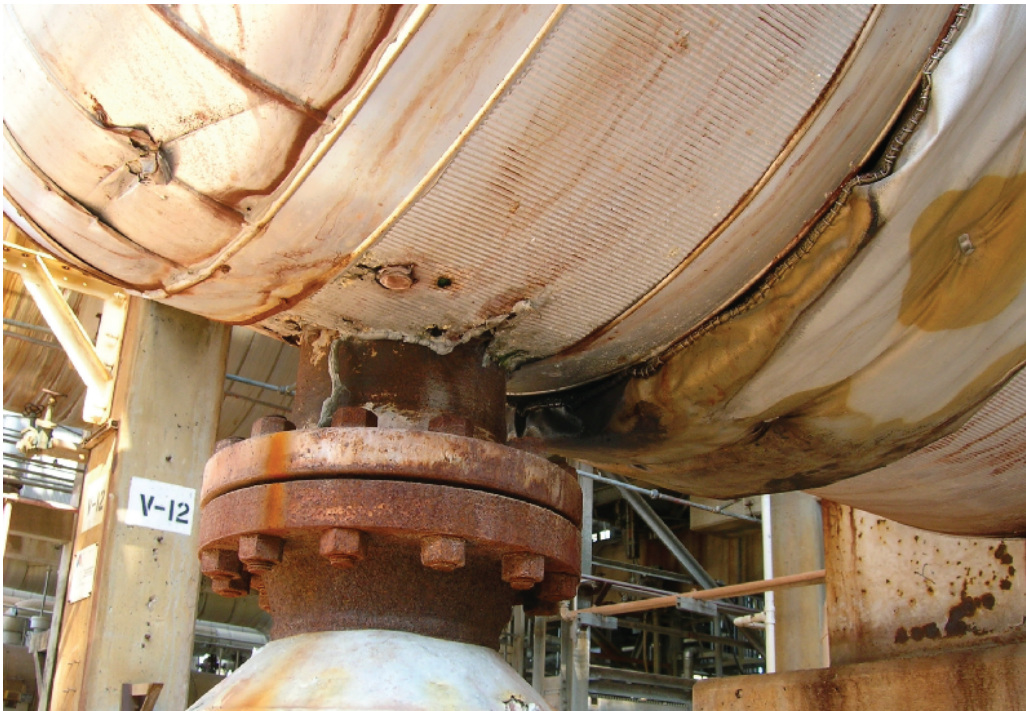
Fig. 4: Plant environment and acidic product leakage have eaten away the aluminum jacketing on this vessel—a clear indicator of moisture-saturated insulation.

Currently, the sheet metal most commonly used for insulation jacketing is aluminum; stainless steel is also used, particularly where a corrosive environment is expected outside the insulated pipe or vessel. Two-sides galvanized and aluminized carbon steel have been used in the past for jacketing, usually with poor results. The galvanizing or aluminizing fails quickly, and the sheet metal corrodes; screw holes and untreated cut edges start rusting almost immediately after installation. Aluminum is usually no more expensive, easier to work with and much more durable, although even aluminum can't always hold up to a refinery or chemical plant's internal chemical fume and splash environment.
