New Zealand is well known for its wines and its environmental management. The upgrade of a Marlborough winery wastewater treatment system included two new 15-megalitre lagoons. One was a covered anaerobic system for untreated wastewater and the other was an uncovered storage system for treated wastewater.

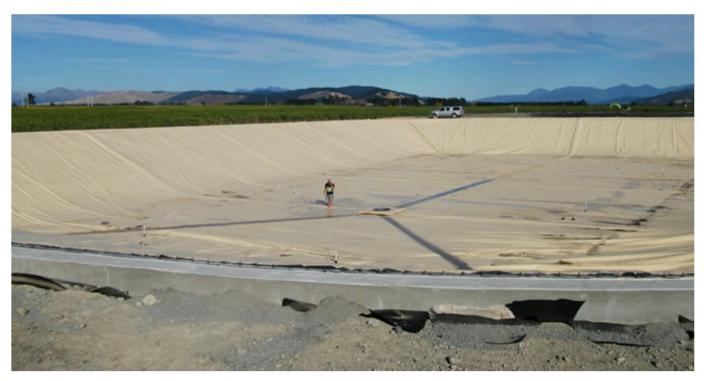
Photo by Viking Containment.

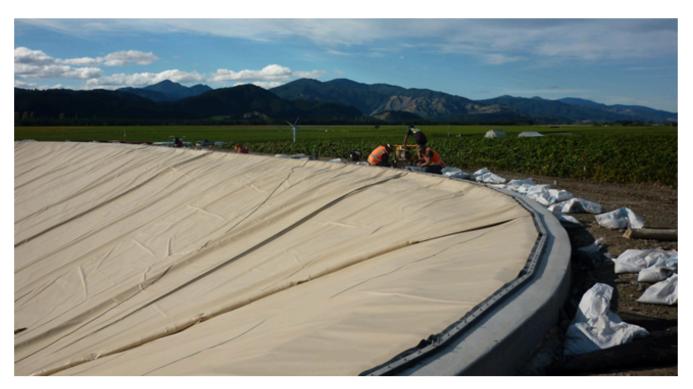
A "tension plate" floating cover system was used for the wastewater treatment pond. Here: a mechanical batten bar and rubber gasket system seals the polypropylene cover to the ring beam. Photo by Viking Containment.

All factory panels and onsite seaming was air pressure tested to ensure the cover was gas tight. For the cover perimeter, a mechanical batten bar and rubber gasket system sealed the cover to a concrete ring beam.
