Warning!

NOT ALL POLY PIPE FITTINGS ARE **PLASSON**.

Product Advice

Product: Plasson® Series 7 Fittings with Black Nuts

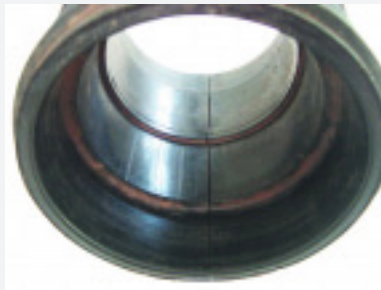
Failed body with longitudinal split

Non-Plasson fittings differ in dimensions and construction from the Plasson range. These differences cause problems when non-Plasson parts are used in replacements on Plasson bodies. A non-Plasson nut can be applied to a Plasson body, but it is not guaranteed to work to the Plasson standard.

- ✓ Specify Plasson® Series 7 Fittings with Black Nuts
- ✓ Ensure Fittings are Branded "Plasson®"
- ✓ Use Plasson® to Plasson® Fittings for Optimum Performance

✓ Failures have occurred at various mine sites - split bodies and nuts. Unfortunately, some mine sites have 'reacted' by banning the use of the genuine Plasson fittings. The failures in all the reported cases have been identified as being non-Plasson fittings.

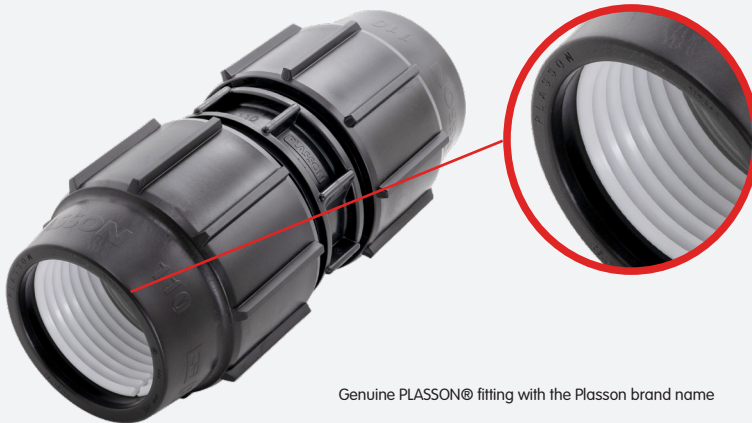
Genuine PLASSON® fitting with the Plasson brand name

Genuine Plasson® fittings have been tried and tested in various environments throughout Australia since 1978 and are the basis for reliable performance in the most demanding and rigorous applications, particularly mining.
