Cementitious Aqualiner® Passes Ten Year Mark

ITL Aqualiner[®] Stands the Test of Time

Cementitious Liner ITL Aqualiner at SRW's Maffra channel, a job undertaken in 2012

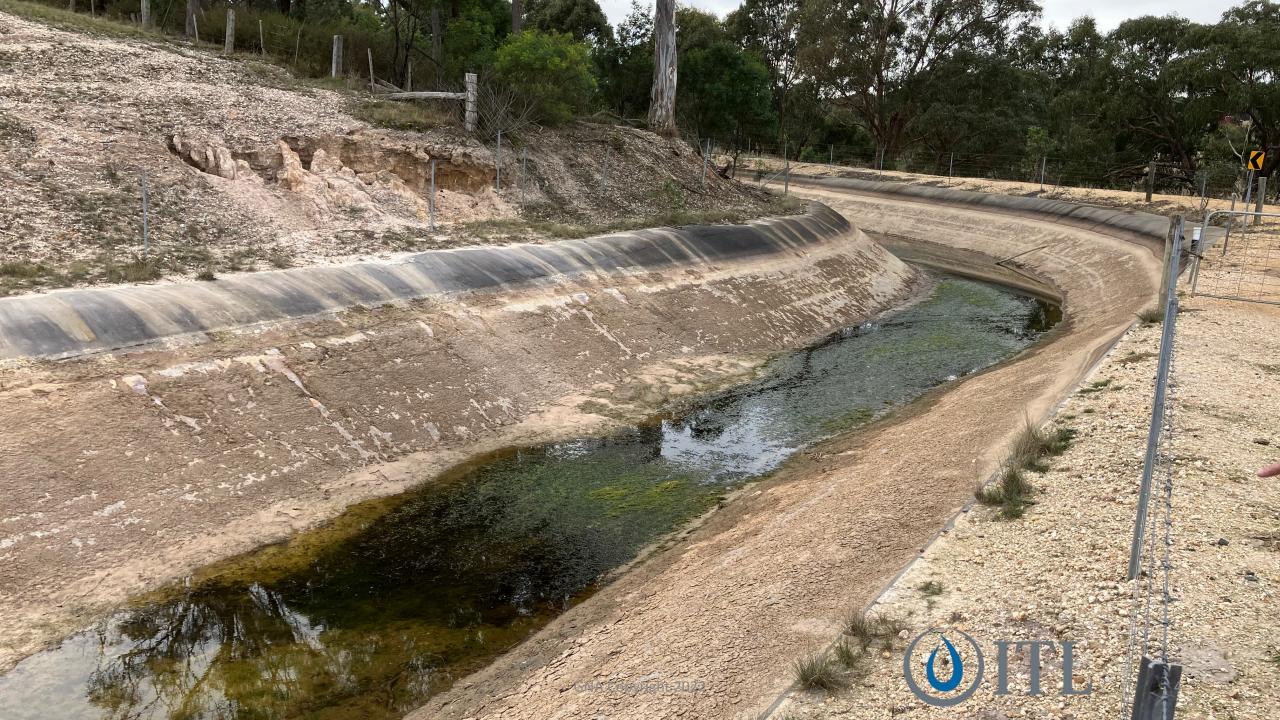
- GHD specified ITL's polymer cementitious Aqualiner for the job.
- ITL inspected the channel and confirmed the channel's integrity.
- In June 2022 when channel water levels are dropped, a joint ITL/SRW inspection determined that any repairs required were of a cosmetic nature, so ITL supplied SRW with \$380 worth of Aqualiner and Aquaseal (joint sealant) to undertake repairs which were carried out by SRW maintenance staff. Not a bad maintenance result for a channel in use all year round after ten years!
