Manuscript title: Factors affecting the tensile strength of bituminous geomembrane seams

Authors: W. Francey and R. K. Rowe

Affiliation: Queen’s University, Kingston, Canada

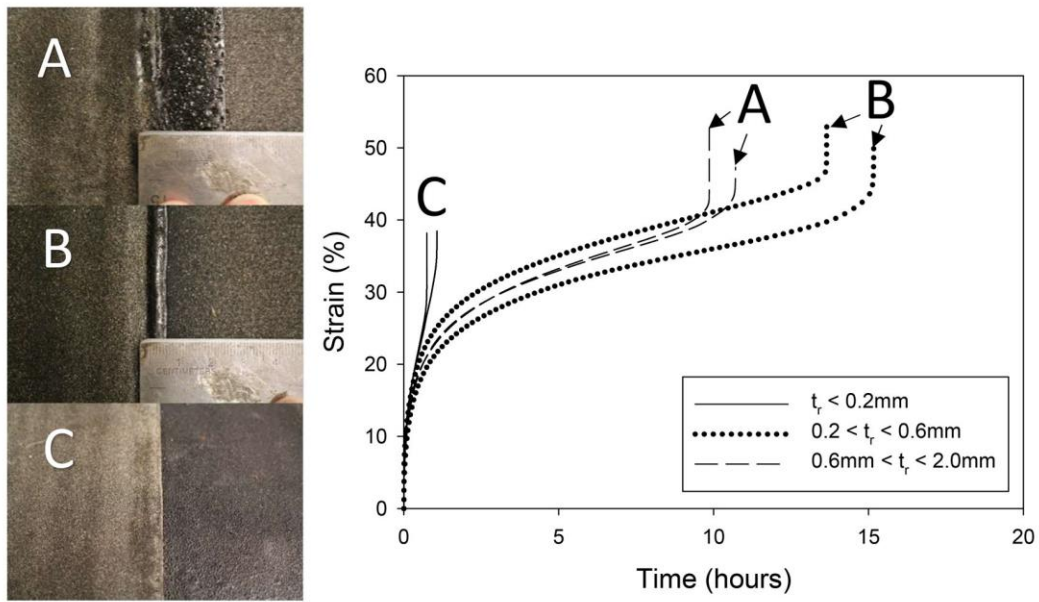
Figure 3

Figure 3. Strain vs time for the six constant tensile load tests conducted at 10 kN/m (45.9% material ultimate strength load). Time until rupture was an order of magnitude greater for seams with ≥ 6 mm squeeze-out and >0.2 mm thickness reduction. Seams with squeeze-out amounts ≥ 20 mm (seam group A) experienced a 28% reduction in seam failure time compared with 6-10 mm squeeze-out seams (seam group B), although failure times were still an order of magnitude greater than <6 mm squeeze-out seams (seam group C).

The foregoing results provide insight regarding thickness reductions of 0.1 mm (squeeze-out 0 mm) and 0.4 mm (squeeze-out 6-10 mm). One manufacturer recommends a minimum squeeze-out of 6 mm (Mafra et al. 2008). To examine the effect of squeeze out, four addition seams having (squeeze-out; t_r) of (0 mm; $t_r = 0.2$ mm), (6 mm; $t_r = 0.4$ mm), and (20-55 mm; $t_r = 0.6-0.7$ mm) were examined (Table 2; lower half). All these seams had a weld factor > 0.8 and tensile shear failure in the sheet. Like the previous $t_r = 0.1$ mm and $t_r = 0.4$ mm seams, a sustained constant load test resulted in failure within the seam rather than the sheet, with an order of magnitude lower seam failure time for seams with thickness reduction ≤ 0.2 mm compared to seams with thickness reduction > 0.2 mm (Fig. 3). However, the 0.6-0.7 mm thickness reduction seams (with squeeze-out beads ranging from 20-55 mm), exhibited an average 28% reduction in seam rupture time when compared with the 0.4 mm seams. Thus, both too little and too much squeeze-out may indicate faster constant tensile load rupture in BGM seams. Greater thickness reduction resulted from greater bitumen loss within the seam interface and greater squeeze-out. It appears that for better longer-term constant tensile load rupture resistance there is an optimum range of bitumen thickness between the geotextile layers with too much ($t_r \leq 0.2$ mm) minimizing the beneficial interaction between the geotextile and bitumen and too little ($t_r \geq 0.6$ mm) also reducing the effectiveness of the interaction although to a lesser extent as too much bitumen. Thus, the optimum condition for this particular BGM appears to be $0.2 < t_r < 0.6$ mm with an optimal thickness reduction of ~0.4 mm and squeeze out of ≥ 6 mm.

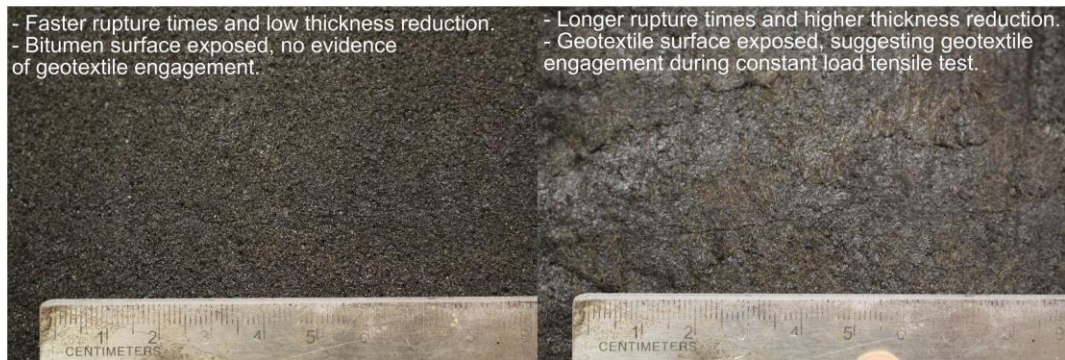
Figure 4

Figure 4. Constant tensile load failure surfaces of the 0.1 mm and 0.4 mm thickness reduction BGM seams. In the 0.4 mm thickness reduction case, a rough exposed geotextile surface was present after testing, with fibers oriented in the direction of applied load. This was absent in the 0.1 mm thickness reduction seam. Given the order of magnitude difference in failure time between these seams, these failure surfaces suggest geotextile engagement played an important roll in seam failure time.

The failure surface morphology of both tensile shear and constant tensile load specimens were examined following rupture and a notable difference was observed for seams that failed within the sheet versus those that failed within the seam. In the event seam failure occurred within the sheet (for tensile shear specimens), a small portion of the overlap within that seam was generally separated during testing and exposed a portion of the geotextile core. This was also noted for constant load specimens, where the 0.4 mm thickness reduction seam's failure surfaces showed a rough surface texture and an exposed geotextile core following rupture. This morphology was absent on the 0.1 mm thickness reduction seams for both tensile shear specimens and the constant load specimens, and instead a smooth bitumen surface and no exposed geotextile core was present after rupture (Fig. 4).

Seams with a thickness reduction ~ 0.4 mm generally exhibited exposed geotextile core failure surfaces, and for the constant load tensile tests, this difference occurred in conjunction with an order of magnitude higher failure time and greater strains at rupture. It is hypothesized that heating of the bitumen impregnated within the geotextile, or the application of stress forcing the softened bitumen into the geotextile pores, resulted in greater geotextile engagement and longer failure times for the higher thickness reduction seams. Geotextile engagement was evident based on the exposed geotextile core and orientation and elongation of geotextile fibers along the axis of applied stress. The two most likely mechanisms contributing to the increase constant tensile load strength of seams following geotextile engagement are: 1) that increased melt depth, or softening of the bitumen within the geotextile core, as well as displacement of bitumen into any potential air voids present within the geotextile, increased the number of fibers engaged during tensile testing, and/or 2) that more intimate contact between the two sheets increased the interface friction of the seam interface, increasing seam performance when subjected to tensile stress. These two factors are not mutually exclusive and may have both contributed to the relative difference in performance between seams. Furthermore, there is the potential for the geotextile cores (of both sheets in the overlap) to become heat tacked to each other, as heat tacking is a common method for sealing geotextile overlaps in the field. However, during heating the geotextile cores are not exposed as they are when heat tacking geotextile seams, effectively limiting the heat they're exposed to and their degree of intimate contact when forced together. Thus, this factor was expected to have played a limited roll in the observed difference in seam constant tensile load performance.

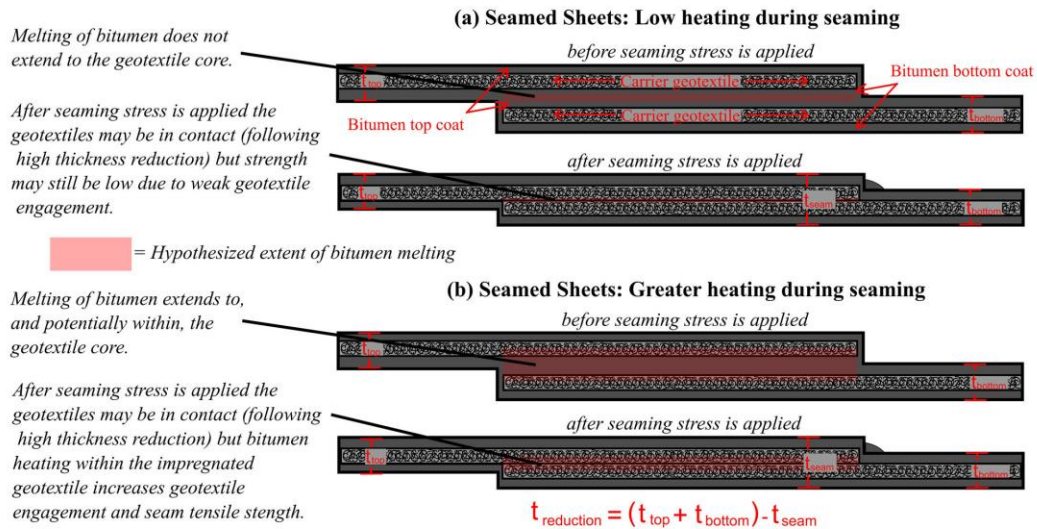
Figure 5

Figure 5. Conceptual view of the hypothesized effect geotextile engagement has on seam tensile shear strength and constant tensile load failure time for (a) low heated seams, and (b) higher heated seams.

Hypothesized influence of bitumen melting and seaming stress on BGM seam strength

A conceptual view of the hypothesized interaction between the seam's bitumen component and its geotextile fibres is shown in Fig 5. High heating and seaming stress appear to increase both the melt depth of the bitumen within the overlap and mix bitumen/remove air voids present within the overlap and geotextile core. Intimate contact between the bitumen matrix and the geotextile fibers post seaming engages the fibers in the geotextile, subsequently increasing tensile shear strength and constant tensile load failure time. Thus, with low heating and low stress (e.g., for hand-torch seams 5 kPa static load in Table 1), the bitumen melting only extended into the BGMs respective top and bottom bitumen coats (i.e., only the bitumen within the seam interface was heated and mixed following the application of seaming stress) and none of the bitumen near the geotextile was affected by the seaming process. The consequent lack of geotextile engagement produced seams with poor strength even with 200 mm overlap. In low heating and high stress cases (e.g., for hand-torch seams, hand roller: high in Table 1), bitumen melting still only extended into the BGMs respective top and bottom bitumen coats but the higher seaming stress forced the geotextile cores into close proximity and removed air voids within the interface, subsequently increasing tensile strength for a given overlap. However, despite the high stress, the failure to melt the bitumen through to the core with a hand torch did not provide the same level of interaction between the fibers in the two cores as in the high heat (field torch and field roller; Table 1) cases, where good interaction was achieved even with low thickness reduction and this was responsible for the adequate tensile strength with the minimum overlap amounts shown in Table 1. Based on this data and conceptual model, it is recommended that BGM seams and patches be created using the manufacturer specified field-torch in order to achieve effective heating through to the core.
